Causes of increasing RLU levels on a surface after cleaning and retesting.

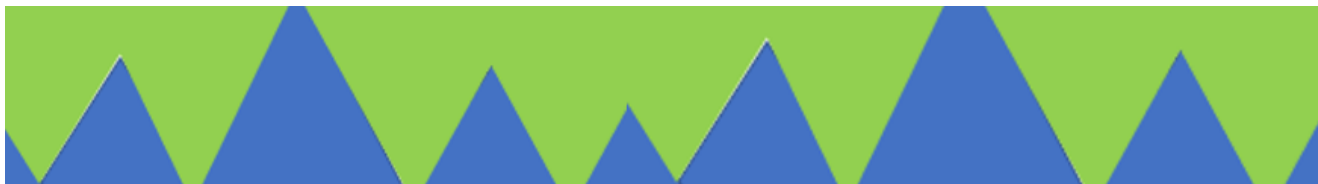
The basic diagram above shows a surface that has not been cleaned. The blue peaks represent the equipment surface at a microscopic level and the green represents organic contamination e.g. Food residue remaining after processing but before cleaning. The surface condition is poor and there are opportunities for product residues to be absorbed or embedded in the small crevices and surface scratches.

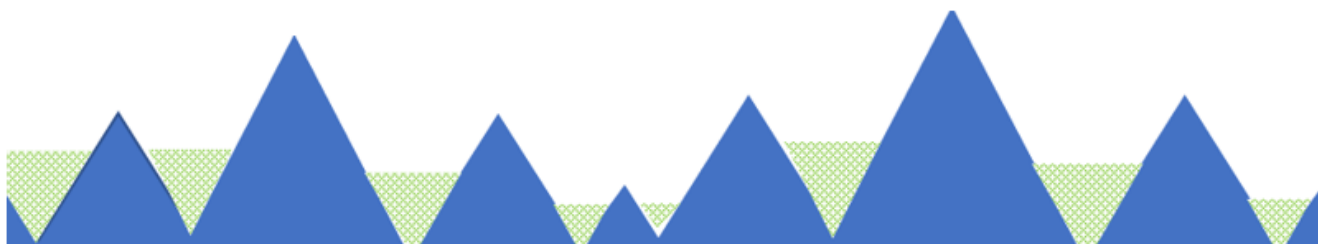
Test result = 60 RLU

The diagram above shows the same surface after cleaning. The majority of the surface contamination has been removed but some still remain trapped in the surface crevices. When tested there is still sufficient contamination to produce a high RLU / Fail result.

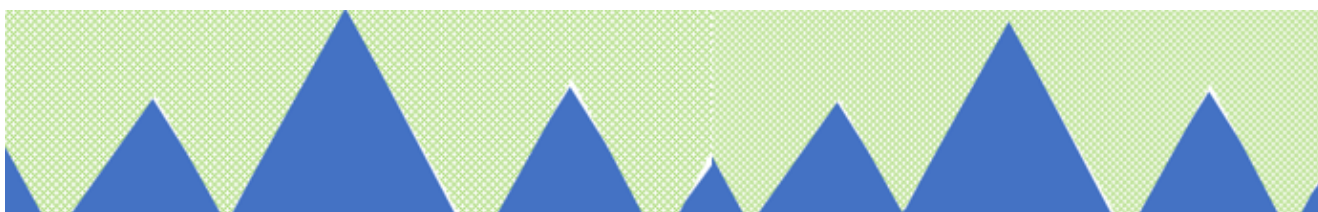
Test result = 120 RLU

The diagram above shows the same surface after recleaning. In this case the following second re-clean. The surface embedded contamination has been loosened and moved to the surface. When this is tested a fail RLU result again is likely and possibly higher than the original result, depending on the product and the surface condition
