Causes of increasing RLU levels on a surface after cleaning and retesting.

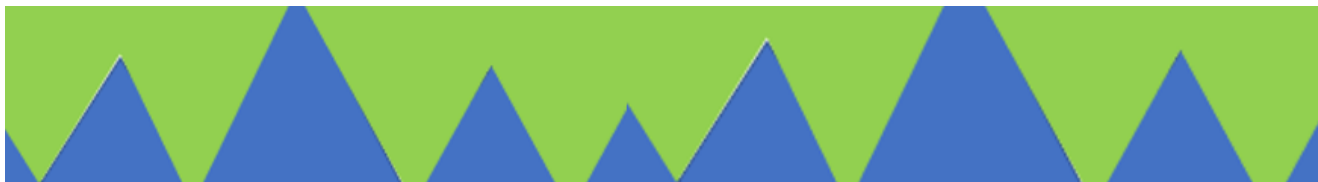
The basic diagram above shows a surface that has not been cleaned. The blue peaks represent the equipment surface at a microscopic level and the green represents organic contamination e.g. Food residue remaining after processing but before cleaning. The surface condition is poor and there are opportunities for product residues to be absorbed or embedded in the small crevices and surface scratches.

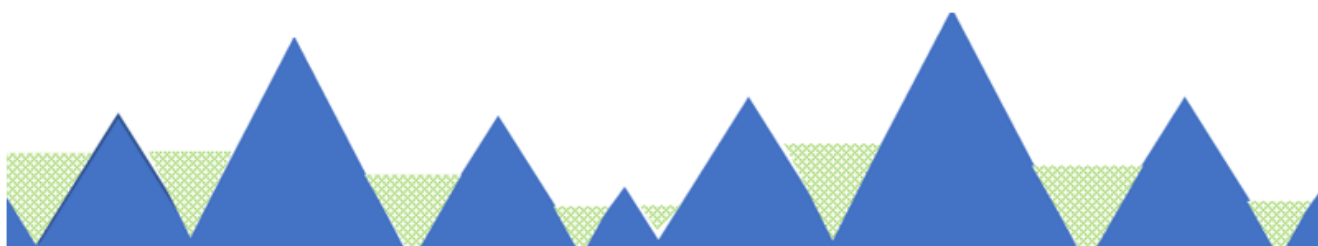
Test result = 60 RLU

The diagram above shows the same surface after cleaning. The majority of the surface contamination has been removed but some still remain trapped in the surface crevices. When tested there is still sufficient contamination to produce a high RLU / Fail result.
